The Gull Wing

This is a technique predominantly called the Gull wing in the UK, there are varying names for this method across the globe.

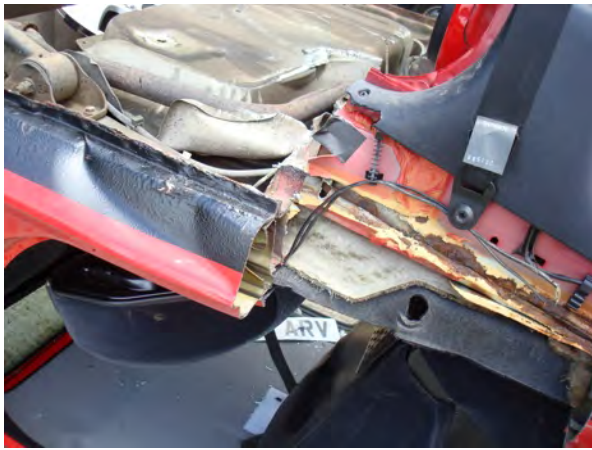
Here you can see we have completed all the cuts with a reciprocating saw as the sill was very weak with the age of the vehicle.

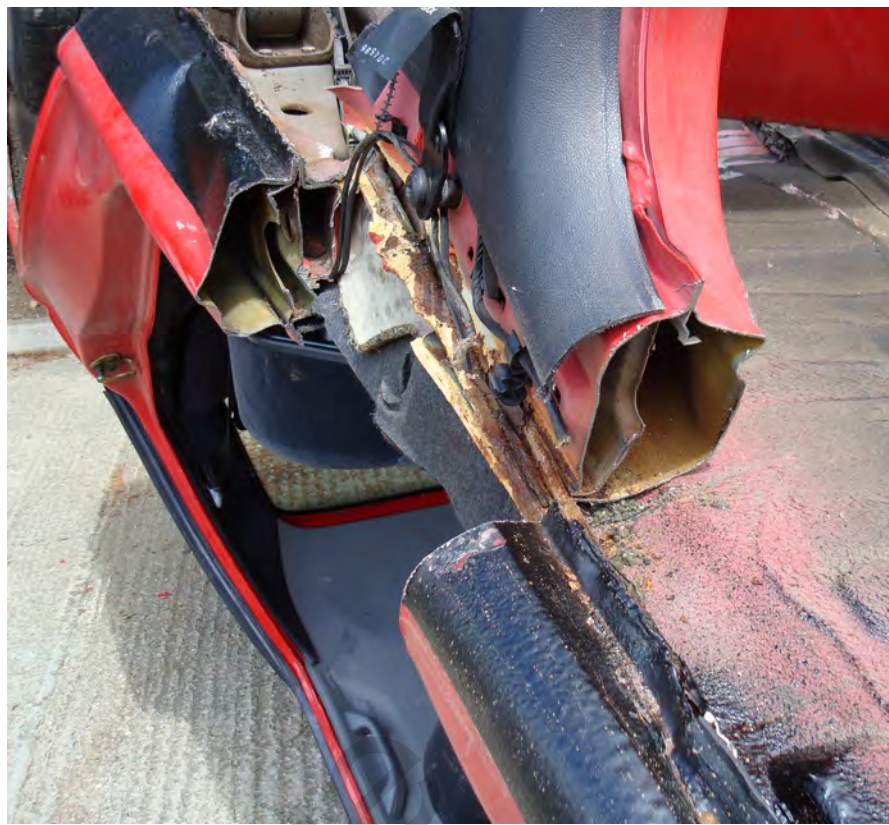
What is also important to look for is additional strengthening in the Sill / rocker channel, as sometimes in newer vehicles we will find a circular strengthening tube that we may not be able to cut through with old cutters or recip saws this will only be visible once you have cut through the outer skin.

What is important to remember is that the cuts need to go through the Sill / rocker channel far enough so that it overcomes the sill strength, ideally all the way to make sure we cut through any structural support in the Sill and floor pan. This will make folding the post a lot easier. Sometimes this can be hampered when using hydraulics if the blades are not large enough to make a deep cut, so several attempts will need to be made to get sufficient depth.

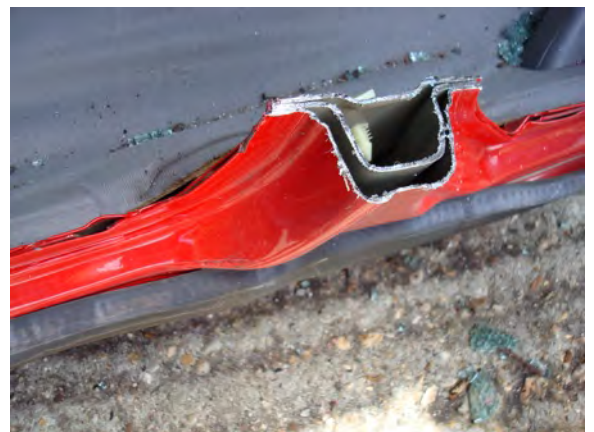
Here we can see the cut in the top of the B-post. A (V) or pie cut would have been a better option to remove the top piece of the post that sticks up. Always remember to check any area we cut for SRS

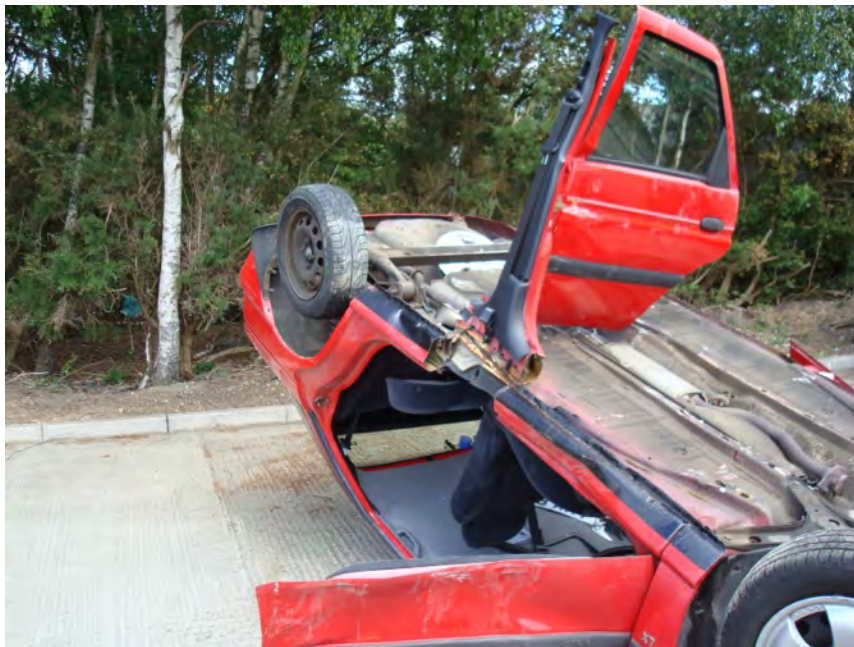
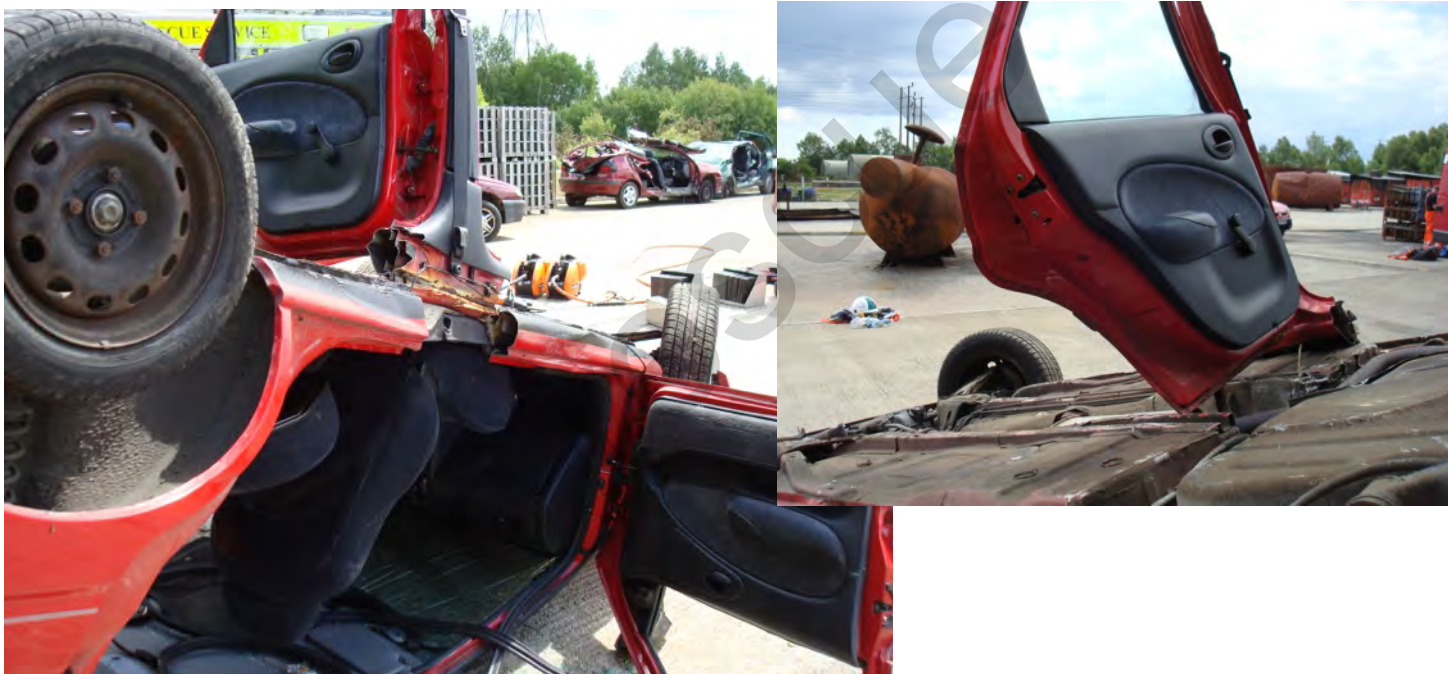
You can see in the pictures the effectiveness of this technique when it works!! As with every extrication method they do not always work to plan or go as smoothly as we would like.

Once the post and door have been flapped they will need securing with a GP line or ratchet system.

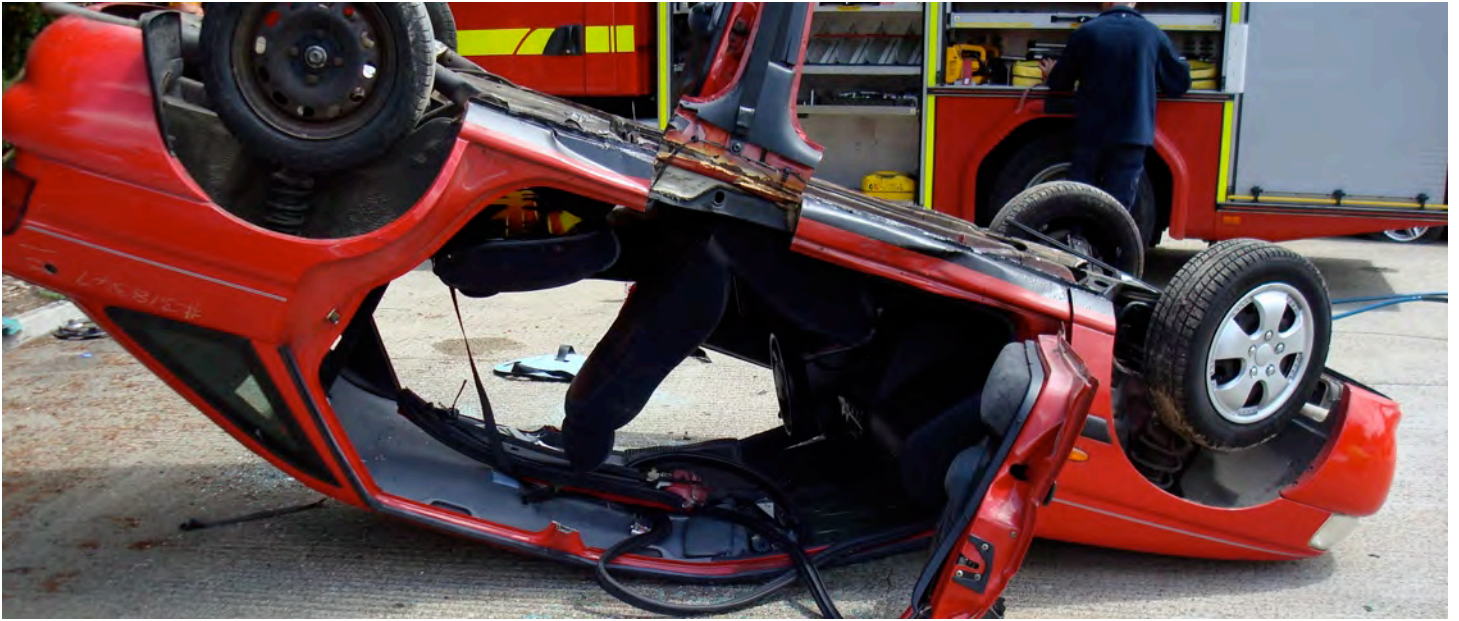
Again here you can see the space we have created for casualty access and removal,

At the time these photo's were taken all stability had been removed.
